# SIX FORKS RANCH

## GEOMORPHIC ASSESSMENT & OPPORTUNITIES FOR IMPROVING STREAM & RIPARIAN CONDITION

PREPARED FOR:  
**Six Forks Ranch, Wyoming**

SEPTEMBER 2021

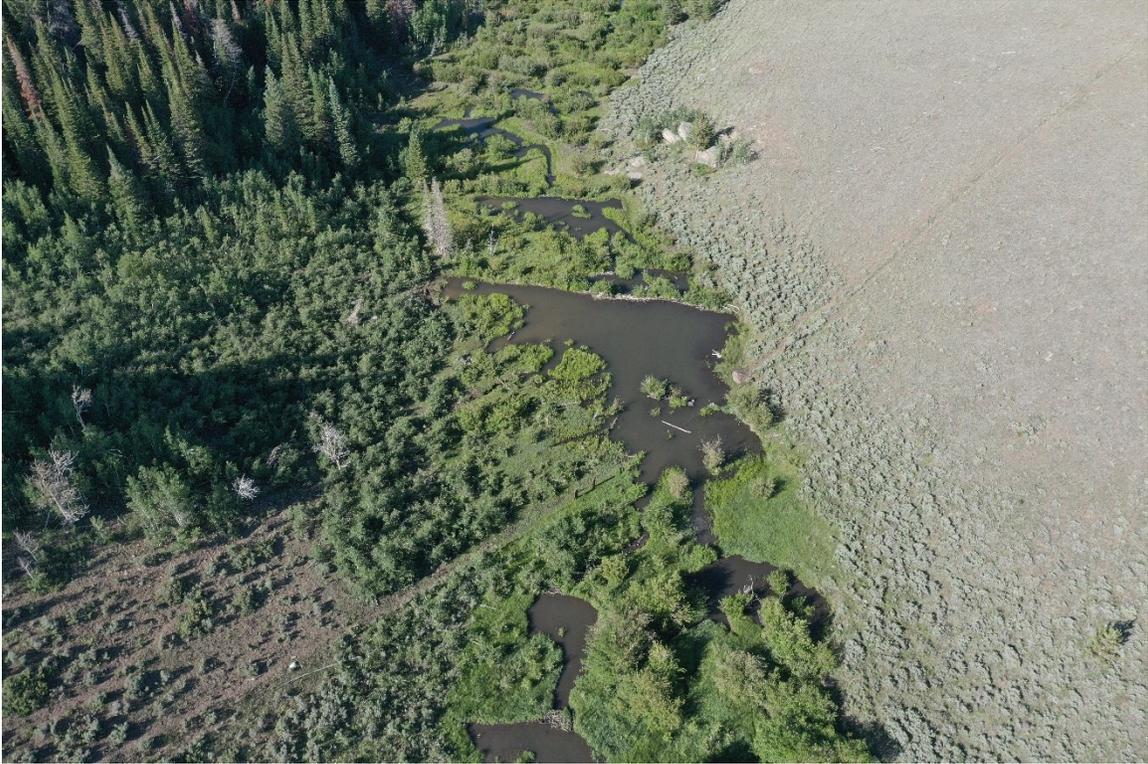
Figure 23 - Active beaver dam spanning the valley bottom on MF Calf Creek at the upstream property boundary.

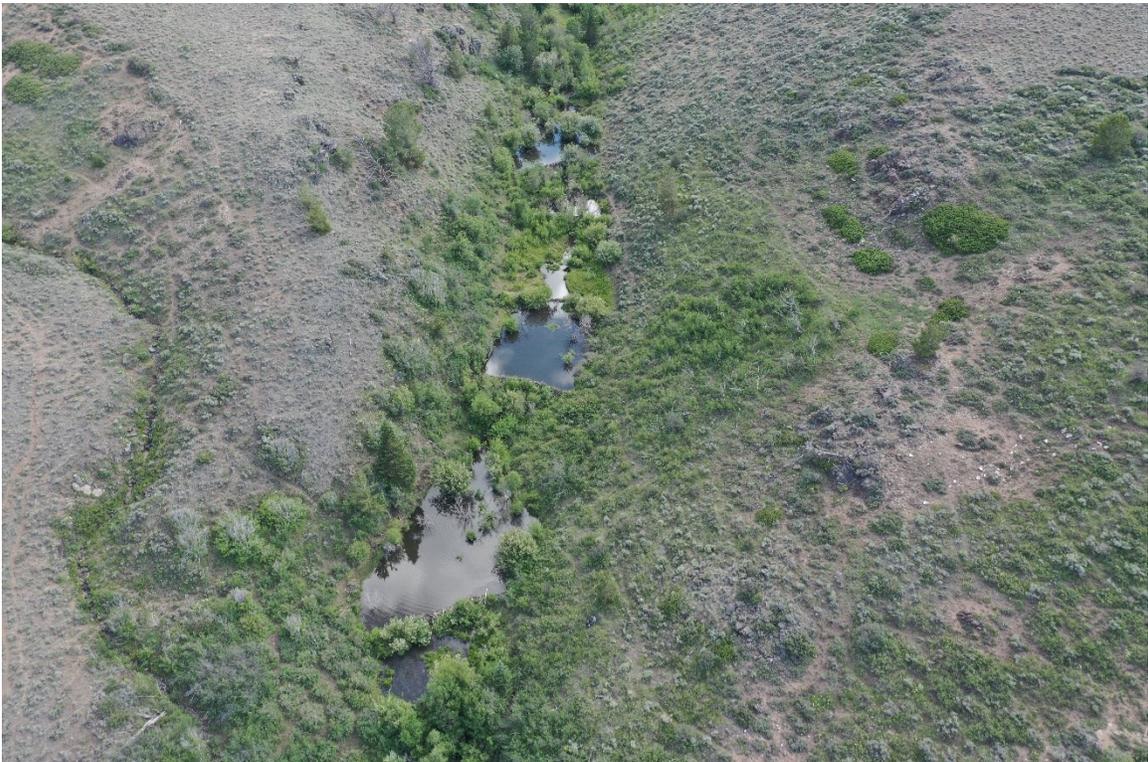
Figure 24 - Series of valley-bottom spanning dams on Shingle Creek.

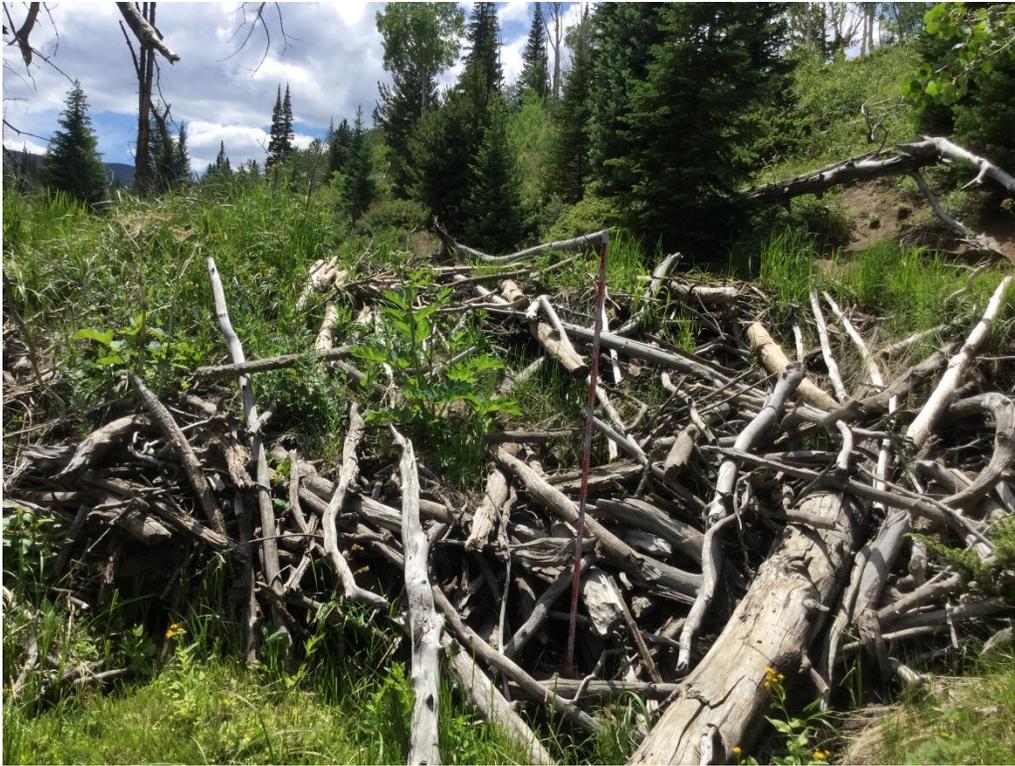
A full field reconnaissance of streams on Six Forks Ranch revealed that beaver have been, and continue to be the most dominant influence affecting hydrologic and geomorphic processes, which together exert a strong influence on riparian vegetation. In most areas, beaver dams span the valley bottom with lengths approaching 60 m (Figures 21-22). Intact and breached dams vary in height, but in some cases exceed 2 m (Figure 25).

**Figure 25 – Abandoned, but intact beaver dam on WF Calf Creek exceeding 2 m in height. (Measuring tape (center) is 2 m tall.) This dam spans the valley bottom and was measures approximately 40 m across.**

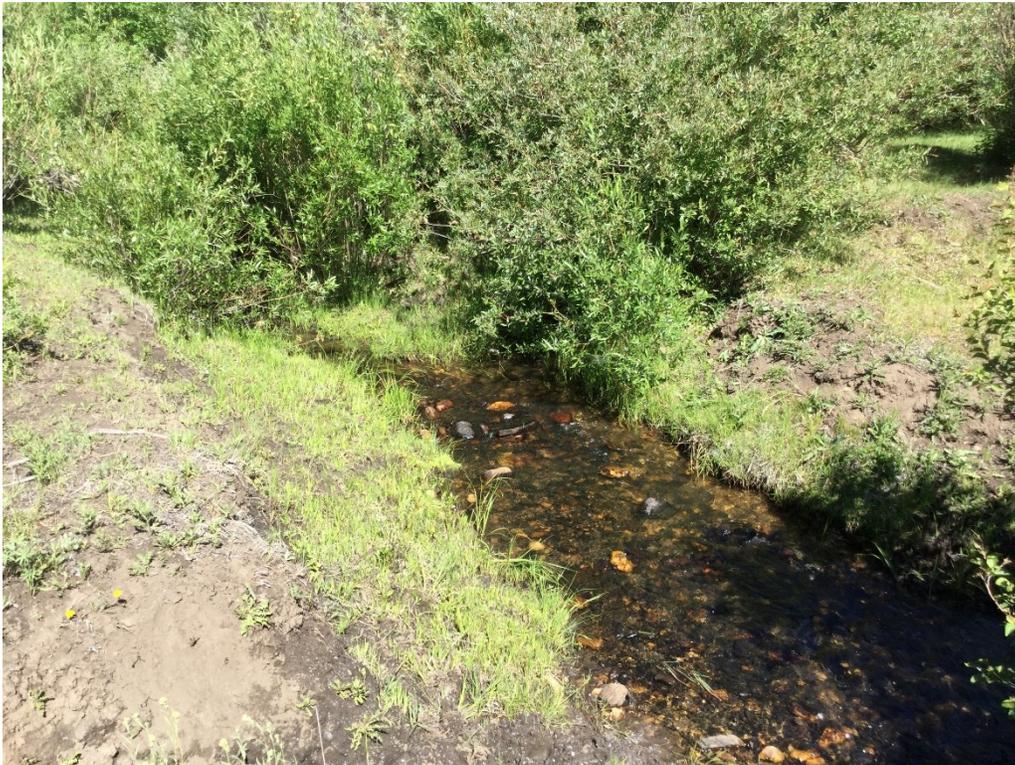
The condition of beaver dams was the most important factor determining vegetation composition and stream characteristics (Figure 8). Where dams are breached, the stream channel has often incised through the sediments that were initially captured by the dam, resulting in channel banks up to 1 – 1.5 m tall, which likely correlates with the deposition forced while the dam was intact and maintained (Figure 26). In other areas, minor breaches or abandonment have resulted in free-flowing waters and channels that are not incised and support abundant herbaceous wetland vegetation such as sedges (Figure 27).

**Figure 26 - Free-flowing section of stream on mainstem Calf Creek where the breaching of a beaver dam led to channel incision that has disconnected the channel from its floodplain.**

We recommend building beaver dam analogues (BDAs) and patching existing breached beaver dams along the mainstem Calf Creek, below the currently maintained beaver dams which are found in the 400 m downstream of the confluence with the WF. BDAs are built manually (i.e., with hand tools) without the need for heavy and invasive machinery, and should mimic natural beaver dam activity by using locally available materials (i.e., wood and sediment) and should be expected to have lifespans similar to natural beaver dams. The only material not available on-site is untreated wooden posts that can be used to increase temporary stability of BDAs when they are constructed in narrow, incised channels where they are more likely to experience breaching. Untreated wood posts typically cost \$3-7 per post, and a single BDA may use between 6 – 30 posts depending on the structure location and specifications. We estimate that in the lower section of Calf Creek most BDAs would require 8 – 15 posts.

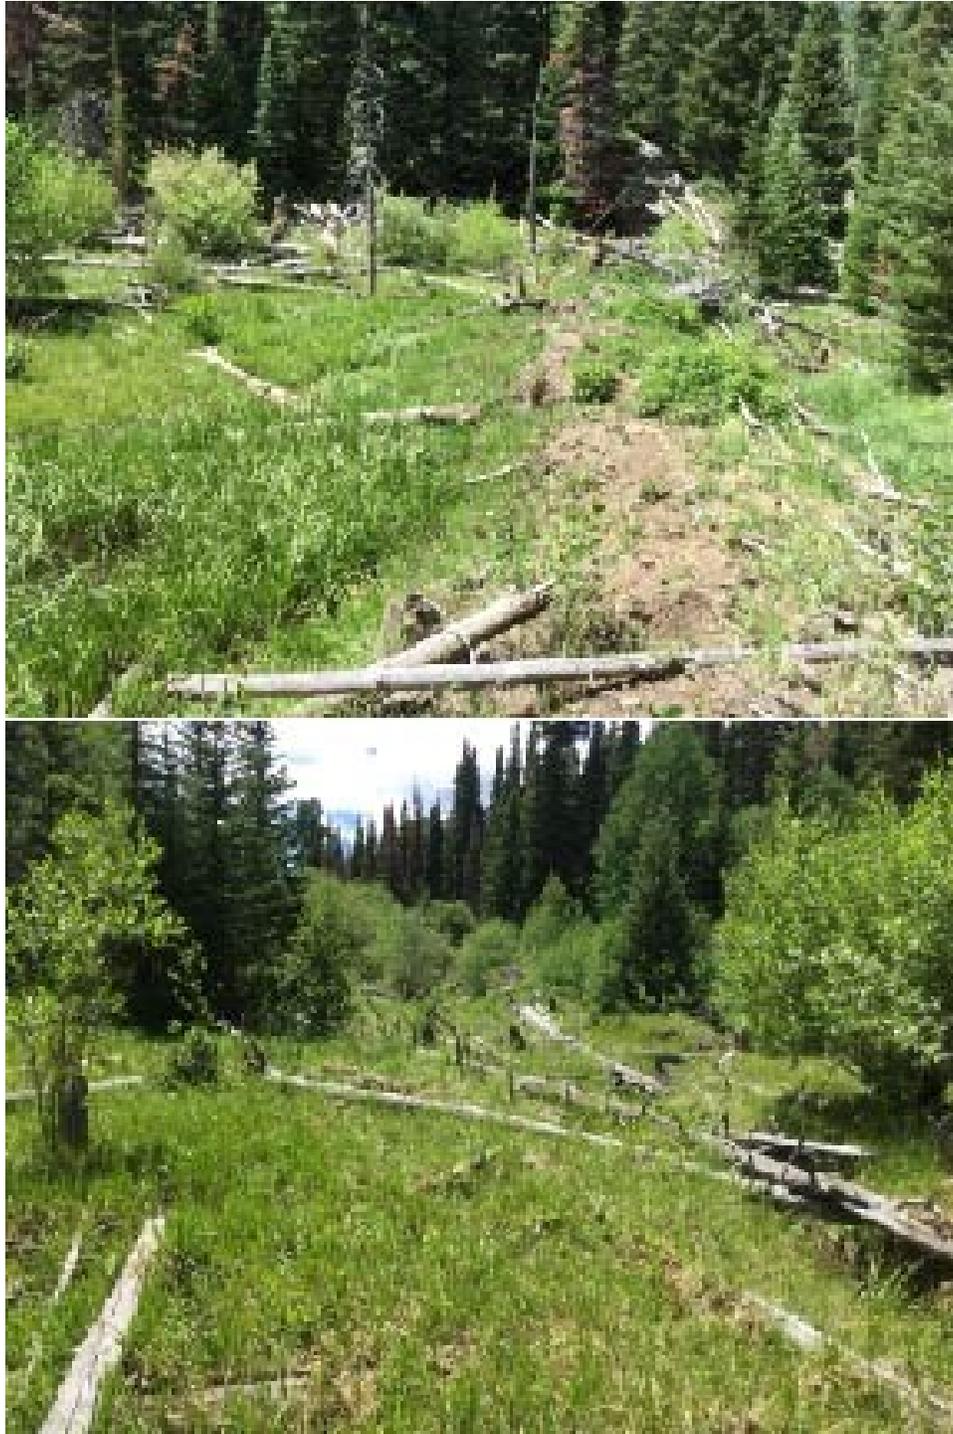
Figure 27 – Abandoned beaver dam on WF Calf Creek no longer ponding water, but where channel is closely connected to the floodplain, which was formed by deposition in the beaver pond, and supporting herbaceous riparian vegetation.

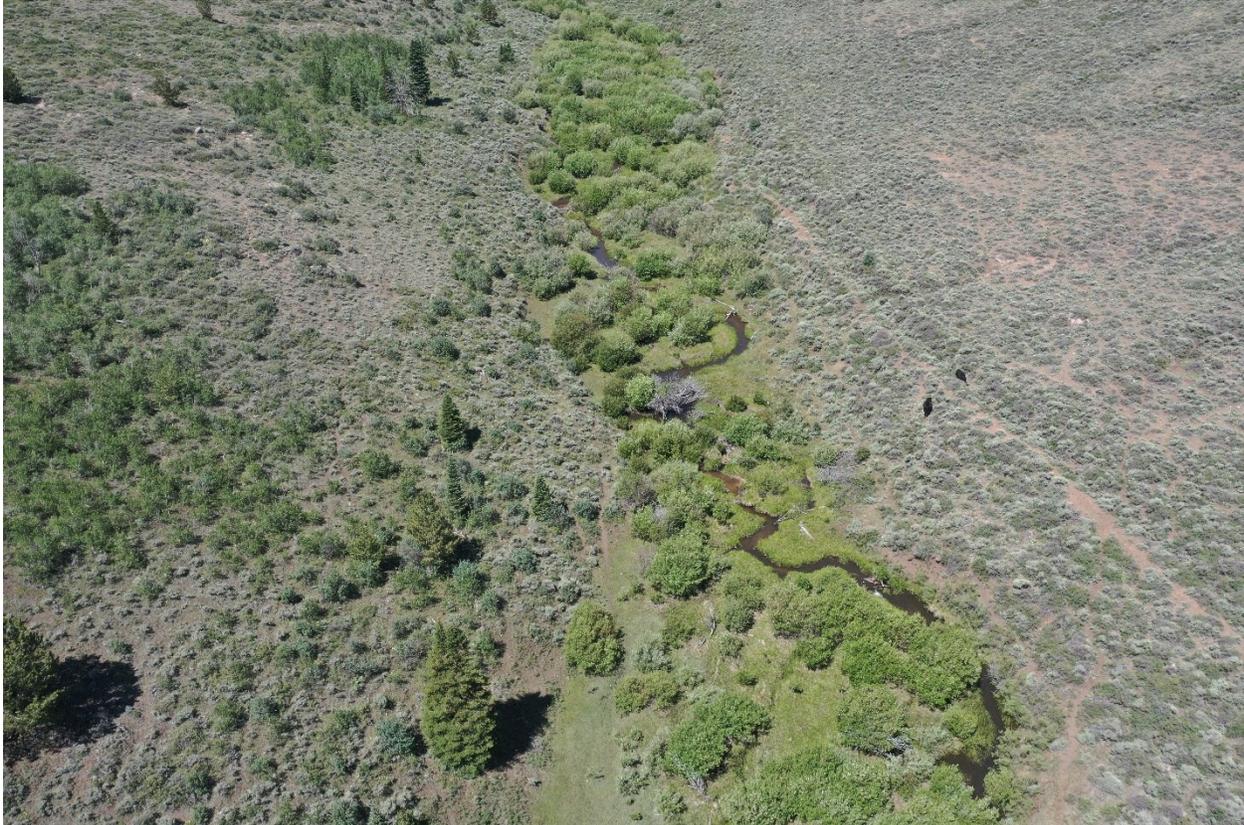
**Figure 28 - Mainstem Calf Creek has significantly less recent beaver dam activity than all other streams, and is characterized by the greatest amount of free-flowing water and disconnected floodplain.**

Across Six Forks Ranch streams and floodplains are generally in good and fully intact conditions. On the lower portions of Calf Creek condition may approach a good/moderate quality based on the current and recent amount of beaver dam activity which is lower than on other streams.

The lower section of Calf Creek (identified in green in Figure 29) spans 2.8 km and drops roughly 100 m. We suggest that up to 75 BDAs could be built in lower portion of Calf Creek. This corresponds to a density of approximately 25 BDAs/km which is consistent with the density of beaver dams built in similar streams as well as found elsewhere on Six Forks Ranch.

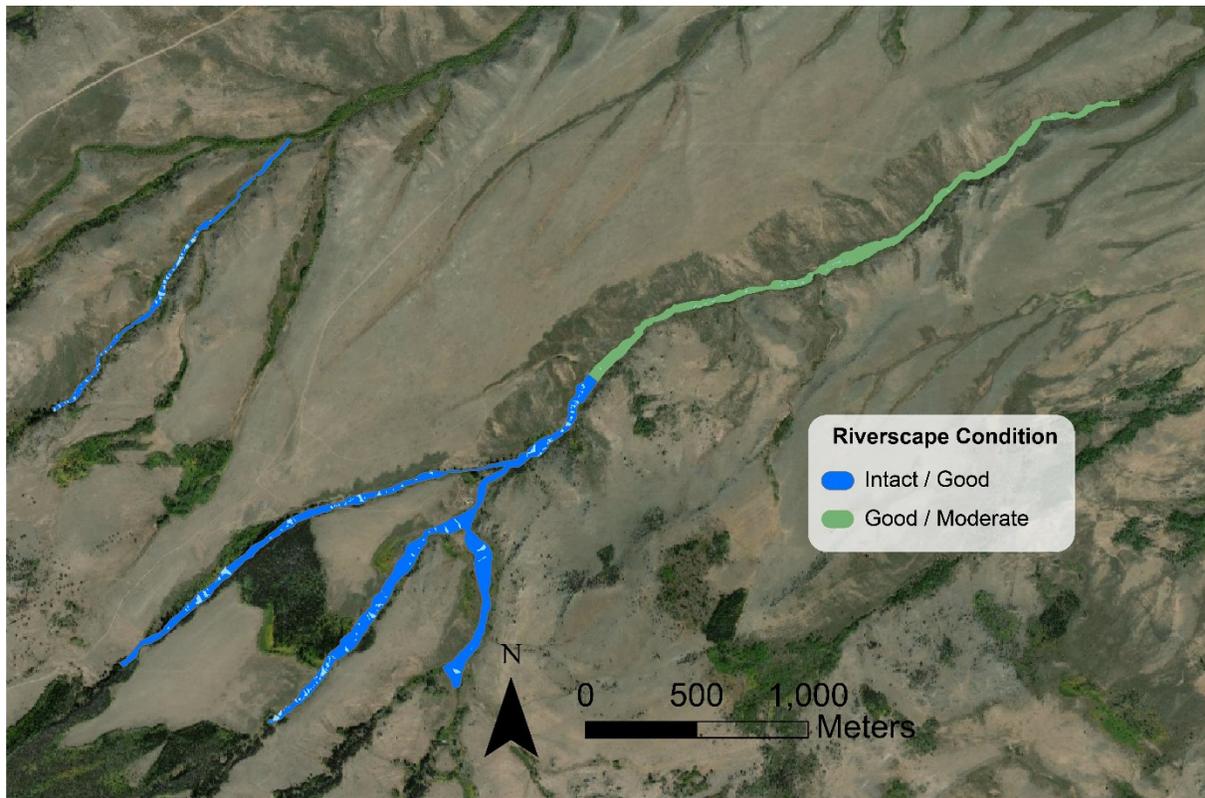
**Figure 31 – Riverscape condition at Six Forks Ranch. We recommend using LTPBR on the lower portion of Calf Creek, and monitoring within an adaptive management framework on EF Calf Creek, MF Calf Creek, WF Calf Creek, Shingle Creek, and the portion of lower Calf Creek immediately below the confluence with the WF.**
