# SIX FORKS RANCH

## GEOMORPHIC ASSESSMENT & OPPORTUNITIES FOR IMPROVING STREAM & RIPARIAN CONDITION

PREPARED FOR:  
**Six Forks Ranch, Wyoming**

SEPTEMBER 2021

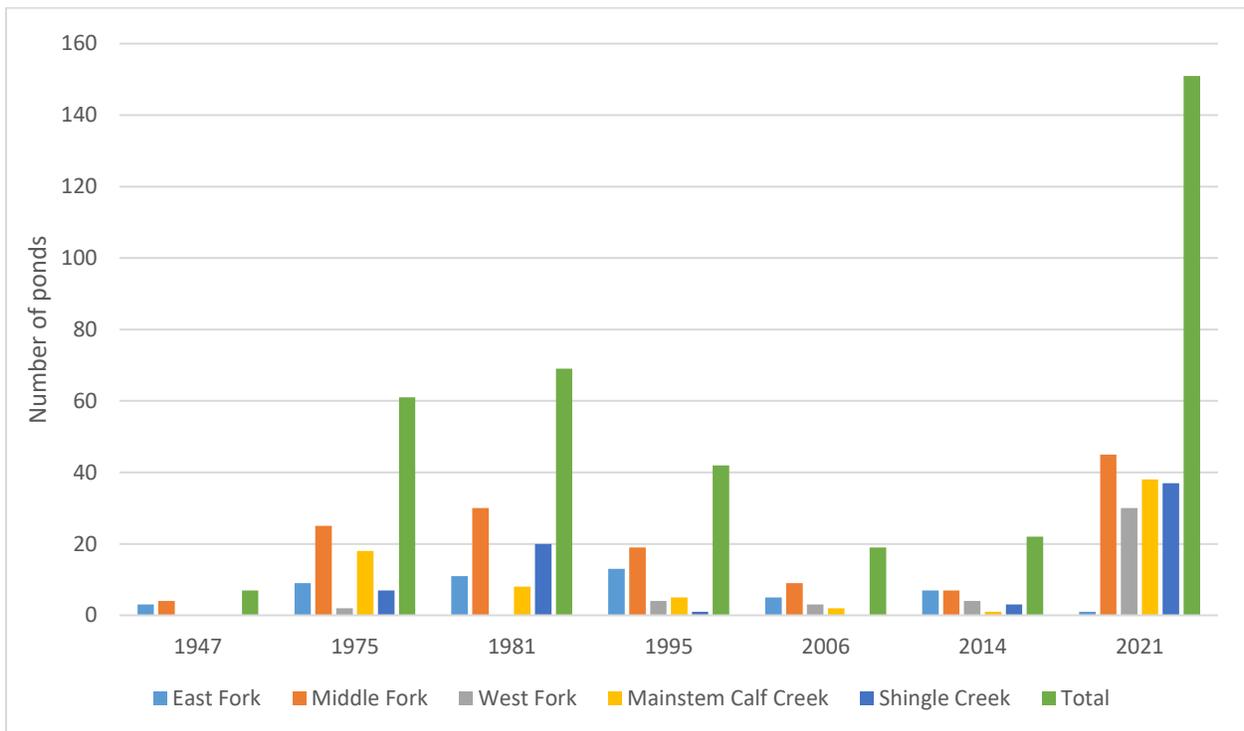
**Figure 19 – Total number of ponds along East Fork, Middle Fork, West Fork, Mainstem Calf Creek, and Shingle Creek. Note that the large increase of total ponds in 2021 is likely due to higher resolution imagery that allowed for the identification of much smaller ponds. An assessment that is less sensitive to the resolution of imagery is shown in Figure 8.**

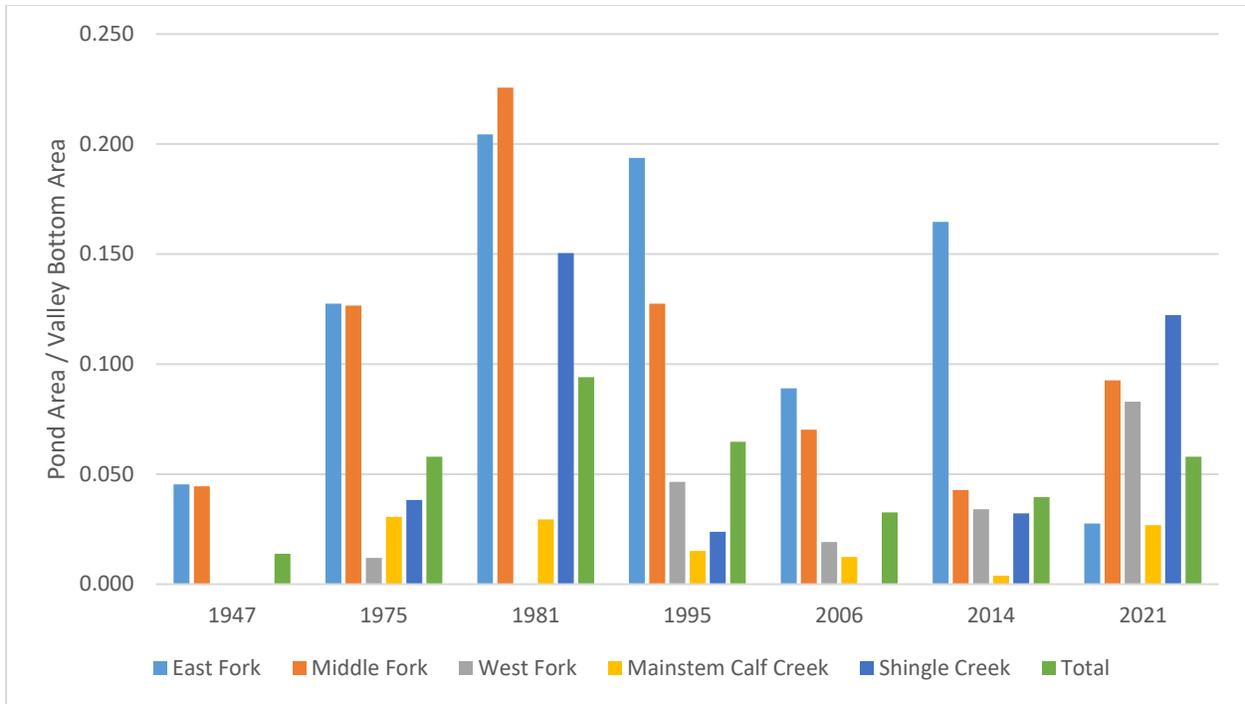
**Figure 20 – Area of pond as a percent of the total valley bottom for the perennial streams on Six Forks Ranch. Pond to valley bottom area varies both between streams as well as through time. In streams similar to those found at Six Forks Ranch, areas that area actively dammed by beaver tend to have pond/valley bottom areas of 15-18% (Bartelt, 2021). The total inundation area, which would include both free flowing sections of stream as well as shallow overbank flows is necessarily larger, however free-flowing and overbank flows were not possible to identify from the historic aerial imagery.**

There is significant variability in ponded area between the streams on Six Forks Ranch. Over the past 70+ years the ponded area as a proportion of the total valley bottom has been as high as 23% (MF Calf Creek 1981) while the mainstem has fluctuated between 0 - 3%. A recent study of actively maintained beaver dam complexes showed that in streams similar to those found on Six Forks Ranch, the ponded proportion of the valley bottom ranges from 15 - 18%. This is consistent with the results from EF and MF Creeks from 1975 – 1995. It is essential to understand that this range of values is for actively maintained beaver dams, and that the study did not track how these values change over time in response to natural factors such as high flows, sediment deposition, predation or decreases in food and dam building materials, and we suggest that it would be inappropriate to suppose that this range would be maintained across all streams through time. Nonetheless, neither the WF Calf Creek or mainstem Calf Creek appear to have reached these levels at any point in the last 70 years, though here again we caution that the time between photos may be too large to capture a more nuanced understanding of beaver dam dynamics. Also note that due to only partial coverage of the mainstem Calf Creek in the 1975 and 1981 imagery, the true value would likely be higher than reported here.

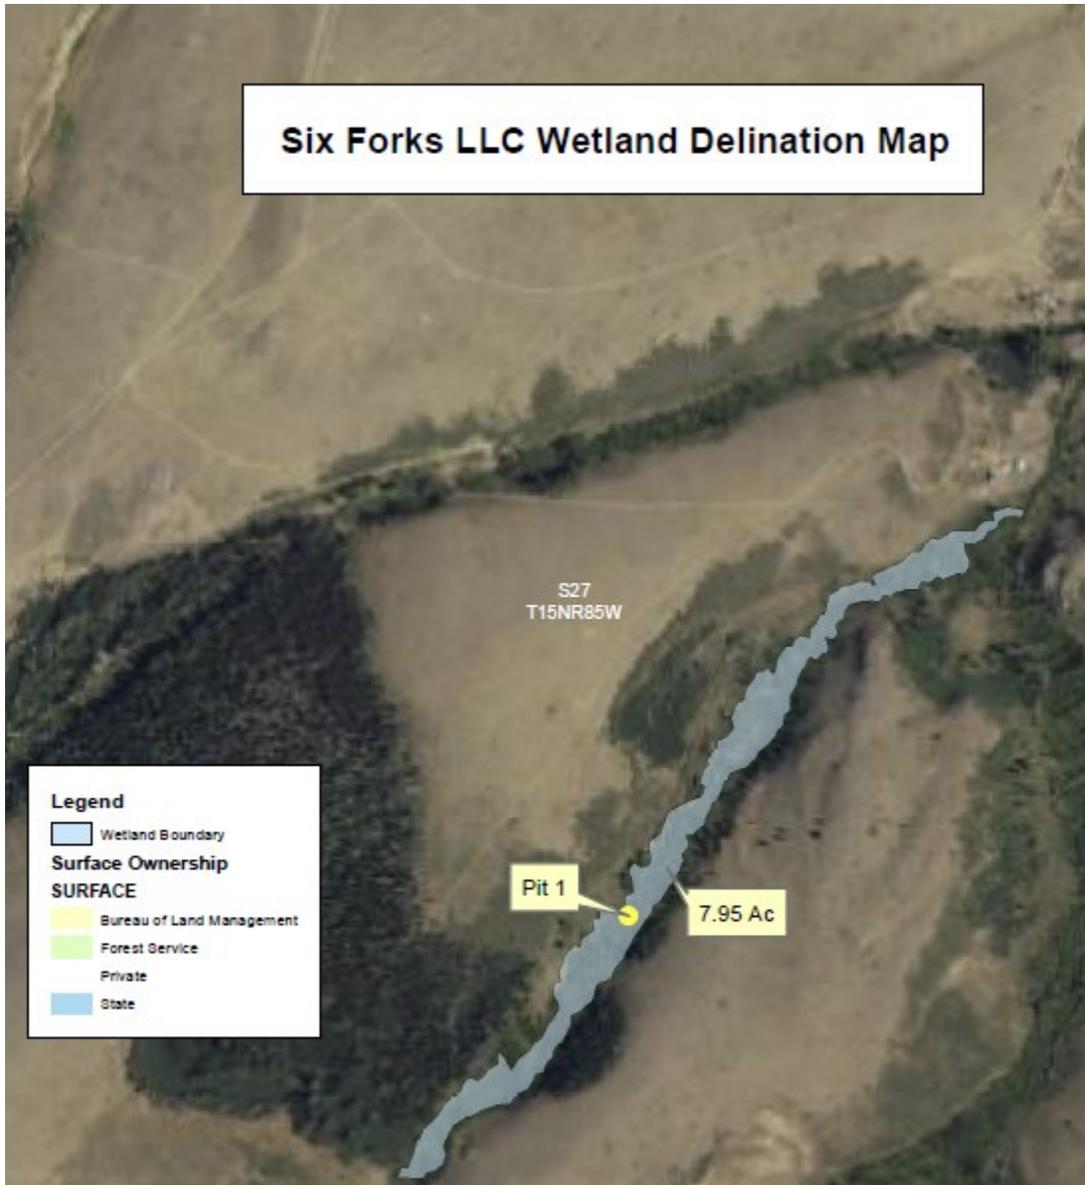
The most recent wetland delineation along MF Calf Creek (performed by the NRCS in June 2021) identified the entire valley bottom as a wetland, suggesting that MF Calf Creek is in good - intact condition. This delineation is also supported by the high amount of historic beaver dam activity evidenced by historic aerial imagery.

Figure 22 - Map of wetland delineation on Middle Fork Calf Creek performed by the Natural Resources Conservation Service (NRCS) in June 2021.

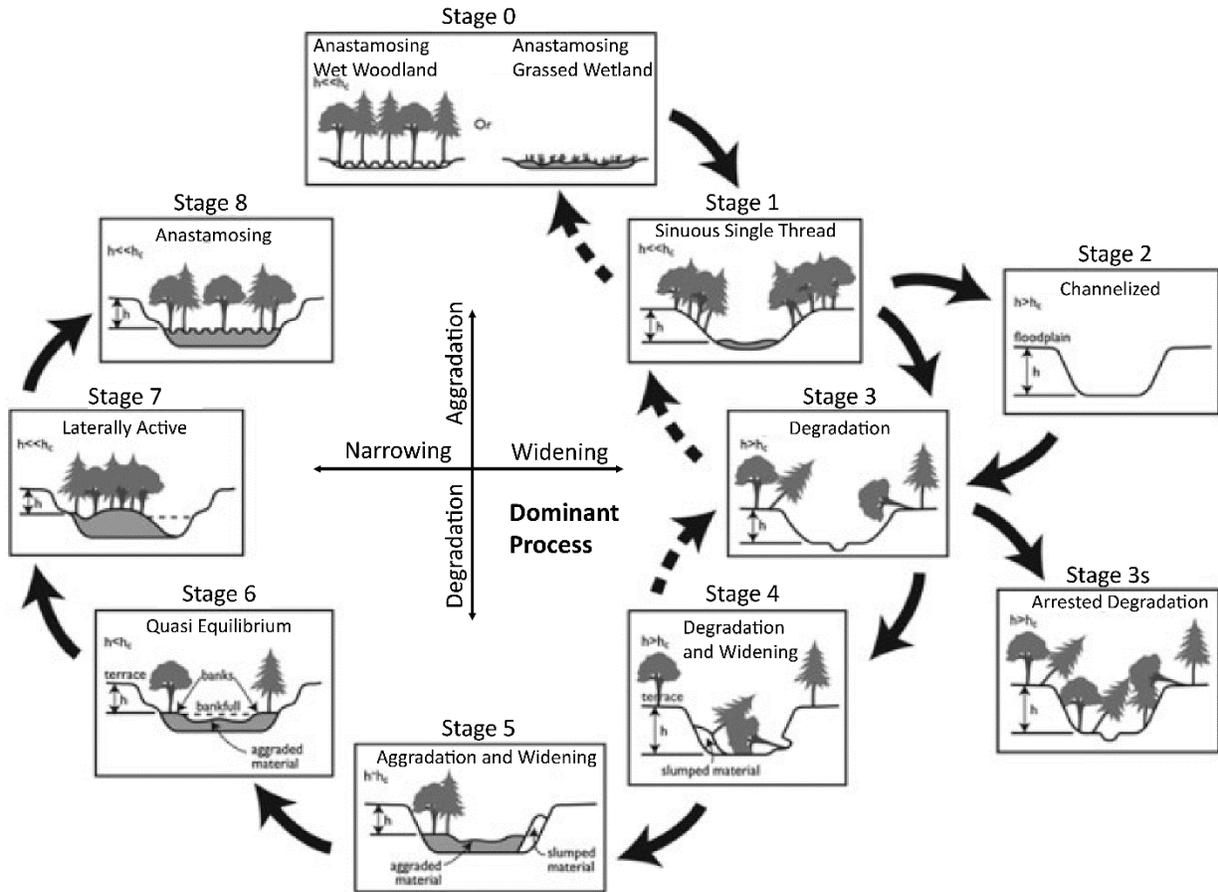
Figure 29 – Stream evolution model presented by Cluer and Thorne (2014). In response to varying levels of beaver activity streams on Six Forks Ranch are generally characterized by Stages 0 – 3, and as illustrated above can transition between stages as beaver dams are built and breached throughout the watershed.

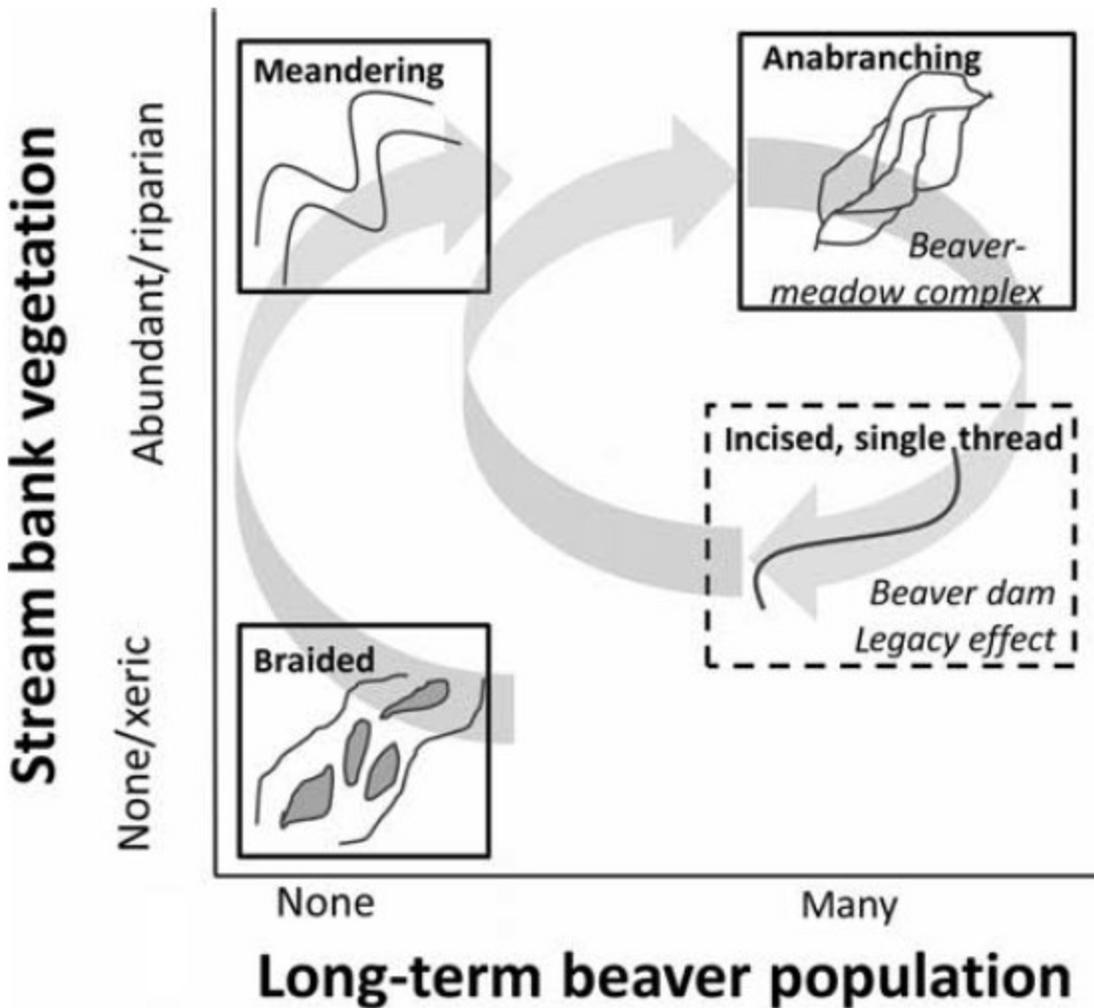
Figure 30 – Reproduced from (Polvi and Wohl, 2013). Six Forks Ranch vegetation fits the ‘abundant/riparian’ category while the long-term beaver population though difficult to characterize is clearly present in sufficient abundance to build persistent dams. As such we can expect the stream channel to move from an anabranching beaver-meadow complex to incised, single thread or meandering states as the beaver population fluctuates and streambank vegetation responds to both hydrologic and geomorphic processes.
